OPERATIONAL DIAGNOSTICS OF DAMAGE TO HEAT EXCHANGE SURFACES OF HIGH-PRESSURE RECUPERATION EXCHANGERS IN A BLOCK OF A HEAT AND POWER GENERATING PLANT

Degradation of heat exchange surfaces, recuperation heater, heating block, heat and power generating plant.

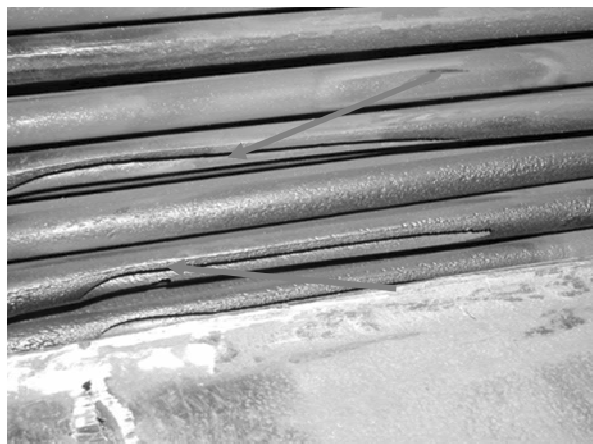
While servicing the studied heat exchangers, a number of surface faults were observed. These included perforations in the tubes in the middle section of the pack (Fig. 1), which is under the direct influence of a steam flow rate from the unregulated turbine steam extraction.

Fig. 1. An image of the perforations of tubes of a heater located opposite the piping feeding steam to the heat exchanger [12]

The above discussion based on carried out research indicates the existence of the perforation of tube walls in the studied heat exchangers. They could be due to intensive degradation processes of the erosive-corrosive nature caused by the inflowing steam. Intensification of the erosive process was caused by the blow through of the steam, which was the result of a low level of condensate and was accompanied by the increase of speed and flow of the steam. The correctness of this conclusion is confirmed by the location of tube wall perforations, which occur opposite the pipe supplying the steam to the heat exchanger. The intensification of the erosive process could have also been influenced by the quality of water feeding the steam boiler. Therefore, during the operation of a heating block, the quality of water should be systematically controlled.

Therefore, operation of a heat exchanger should take place at a carefully maintained level of condensate in the heaters. In order to avoid emergency switch-off of the block due to an increased level of condensate, there should be an automatic system allowing a fast “dump” of condensate from the heaters. Heat exchange surfaces of the heaters of water feeding the boilers undergoing such changes should be systematically controlled with endoscopic methods.

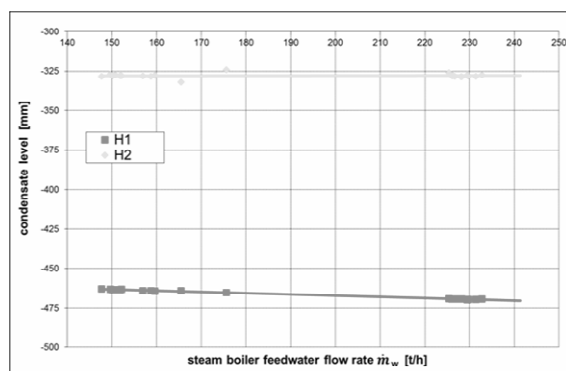
Fig. 4. A relationship between H_1 and H_2 condensate and the steam boiler feedwater flow rate \dot{m}_w

Figure 4 shows that, together with the growth of the mass flow rate of the water feeding the steam boiler (load of the heating block), the level of condensate in the HPR1 heater decreases, until it is below its acceptable value (see Fig. 3). On the other hand, the level of condensate in the HPR2 heater

remains constant regardless of the block load, and it does not go below its acceptable value. Based on the above, it can be concluded that, during the operation of the studied heaters, states of faulty non-designed operation occur especially in the range of maximum loads of the heating block.

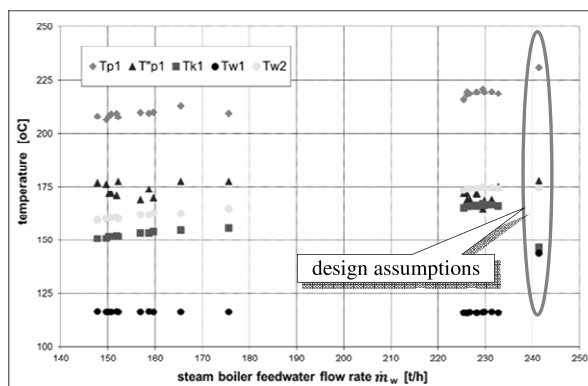
The relationship presented in Fig. 5 indicates that, in the HPR1 heater, there is no respective relationship between steam, water, and condensate temperatures, especially for the maximum block load. The temperature of water feeding the boiler at the inlet to the HPR1 (T_{w1}) is lower (much lower than designed) than the temperature of the condensate T_{k2} . On the other hand, the temperature of the water feeding the boiler at the outlet from HPR1 (T_{w2}) is higher than the temperature of the condensate and saturated steam T''_{p2} , which may support the previous assumption that steam blow through takes place in the HPR1 heater.

Fig. 5. A relationship of the temperatures of steam, water, and condensate characterizing the operation of the HPR1 heater versus the steam boiler feedwater flow rate \dot{m}_w , T'_{p1} – temperature of the dry saturated steam in the HPR1

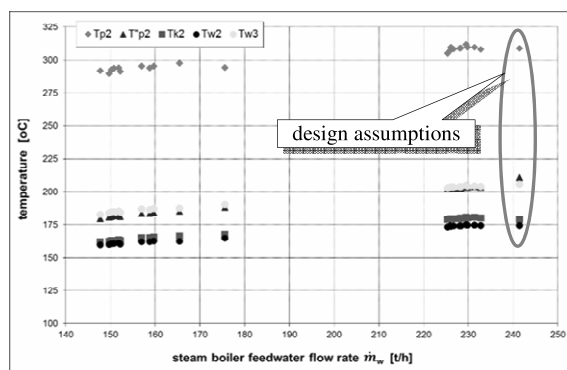
From the relationships shown in Fig. 6, it can be concluded that the temperatures of steam, water, and condensate characterizing the operation of the HPR2 heater remain in correct relationships with each other in compliance with the designed assumptions in the whole range of loads of the heating block. This includes the temperature of the water feeding the boiler at the outlet from the HPR2 (T_{w3}) being equal to the temperature of saturated steam T''_{p2} .

Fig. 6. A relationship of the temperatures of steam, water, and condensate characterizing the operation of the HPR2 heater versus the steam boiler feedwater flow rate \dot{m}_w
 T'_{p2} – temperature of the dry saturated steam in the HPR2

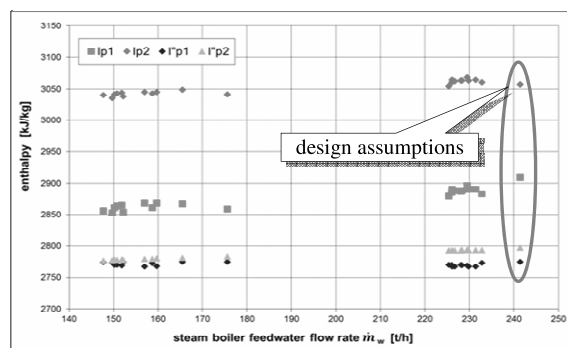
These conclusions pointed to the need of determining a relationship of the enthalpies of superheated and saturated steam at the inlet to the studied heaters versus the load of the block and comparing them with the results of calculations on designed values, which is shown in Fig 7. The enthalpies were determined based on the values of temperatures shown in Figs. 5 and 6 and the pressures of steam measured at the inlet to the studied heaters.

Fig. 7. A relationship of superheated steam i_p and saturated steam i'_p at the inlet to the HPR1 heater (i_{p1} , i'_{p1}) and to the HPR2 heater (i_{p2} , i'_{p2}) versus the steam boiler feedwater flow rate \dot{m}_w

From the relationship shown in Fig. 7, it can be concluded that steam parameters at the inlet to both heaters for different loads of the heating block maintain similar values of enthalpy close to the designed values. It confirms the correct way of controlling the load of the heating block (“quality”).

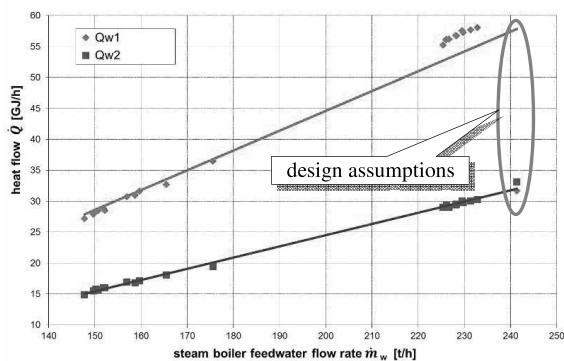
values. A relationship between the determined heat flows and mass flow of the water feeding the boiler \dot{m}_w (block load) are presented in Fig. 8, which shows that, in the HPR2 heater, the heat flow delivered for heating the water feeding the boiler \dot{Q}_{w2} is proportional to the load of the heating block and its maximum value corresponds with the designed one ($\dot{m}_w = 241.4$ t/h, $\dot{Q}_{w2} = 33.09$ GJ/h).

Fig. 8. A relationship of the heat flow rates delivered to heat the water supplying the steam boiler in the HPR1 heater (\dot{Q}_{w1}) and the HPR2 heater (\dot{Q}_{w2}) versus the steam boiler feedwater flow rate \dot{m}_w

However, in the HPR1 heater, the heat flow delivered for heating the water feeding the boiler \dot{Q}_{w1} is almost twice as big as the heat flow determined for designed values ($\dot{m}_w = 241.4$ t/h, $\dot{Q}_{w1} = 31.66$ GJ/h). The increased values of \dot{Q}_{w1} occur mainly for the range of loads of the heating block that is close to the maximum one. Taking into account that, for these loads, there is a low level of condensate (Fig. 4) and a low pressure of steam feeding the HPR1 heater, it can be assumed that a blow through of the steam took place in the HPR1 heater, and thus the part played by the heat of condensation in the whole process of heat exchange was smaller. The above should result in an increased steam flow at the inlet to the WP1 heater. To verify this assumption, mass flows and the speeds of steam feeding the HPR1 and HPR2 heaters were determined. These relationships are shown in Fig. 9 and Fig. 10.

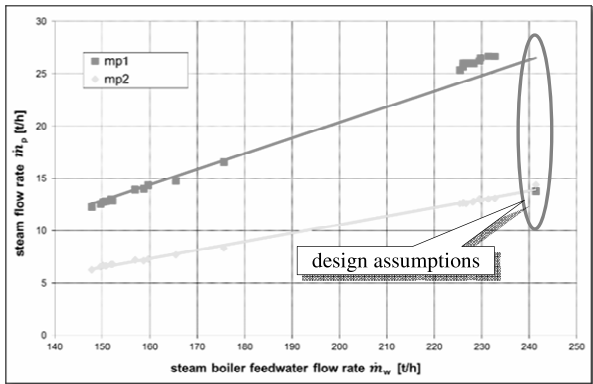
Figure 9 indicates that steam flows calculated from the designed values for the HPR1 and HPR2 heaters are close to each other. The determined steam flow for the HPR2 heater (\dot{m}_{p2}) is proportional to the load change of the heating block with a maximum value corresponding to the designed assumptions. The determined steam flow for the HPR1 (\dot{m}_{p1}) is proportional to the change of load of the heating block; however, it is almost twice as high as the steam flow

derived from designed values. It supports the earlier assumptions on the existence of a blow through of steam at low levels of condensate.

Fig. 9. A relationship of the steam mass flow rates at the inlet to the HPR1 heater (\dot{m}_{p1}) and to the HPR2 heater (\dot{m}_{p2}) versus the steam boiler feedwater flow rate \dot{m}_w
